Cardinal Home Inspections, L.L.C.

General Information

BUILDING ADDRESS: 123 Elm St.
CITY: Boone
STATE: IA
ZIP CODE: 50036
INSPECTION DESCRIPTION: Single Family Home Inspection
SQUARE FOOTAGE: 2225
Picture:

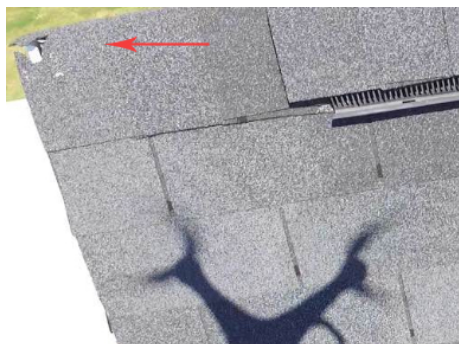
SHINGLES MISSING / DAMAGED? Inspected

One shingle is damaged on the western most peak of the roof.
Recommend further evaluation by a qualified contractor.

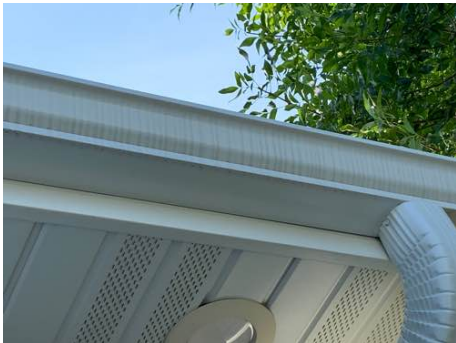
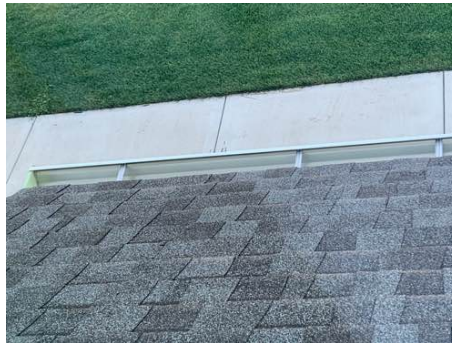
GUTTERS AND DRAINAGE Fair

All of the gutters were cleared at the time of the inspection, however they are showing stains from being clogged in the past. Recommend installing covers to keep out debris.

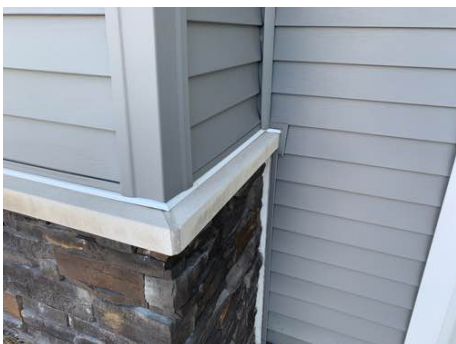
SIDING MATERIAL Vinyl

The majority of the home has vinyl siding with brick veneer

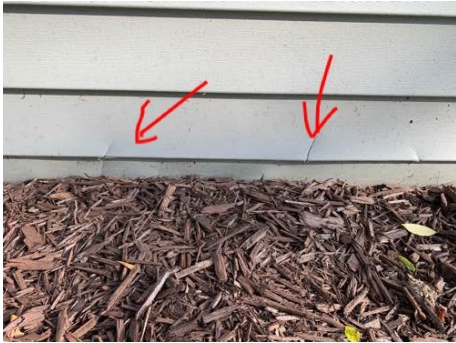
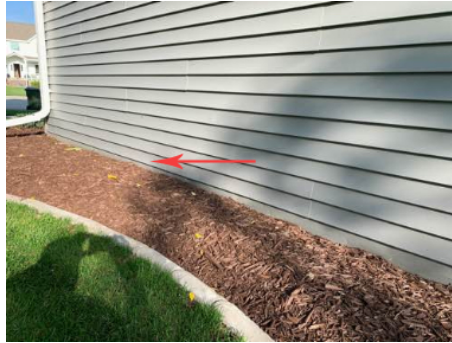
SIDING CONDITION Inspected

The siding is in good condition all around the home with the exception of some minor damage on the north east side. Recommend further evaluation by a qualified siding contractor.

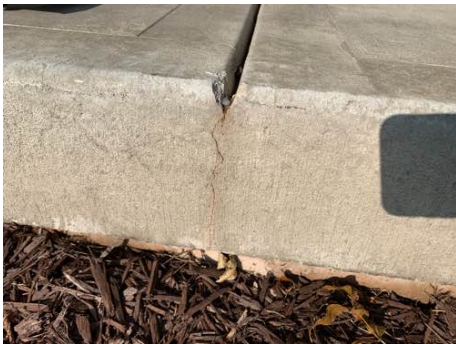
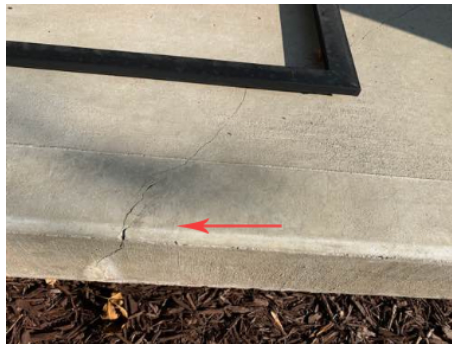
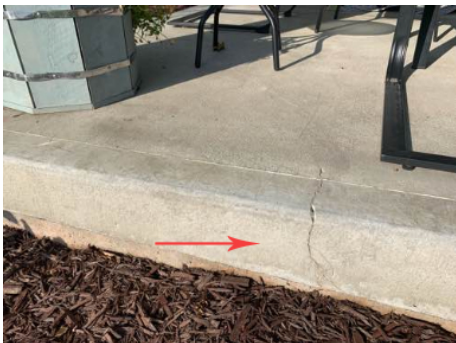
STOOP / PORCH Fair

Concrete shrinkage cracks exist on back porch. These cracks are normal and should not be an issue, however I recommend you monitor these in the future for any possible movement.

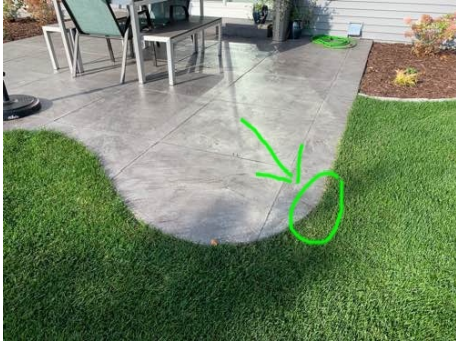
PATIO Inspected

I recommend sealing the stamped concrete patio each year to prevent color loss. There is also a repaired crack on the edge of the patio. I put pressure on it to test it and it appears to be holding up just fine.

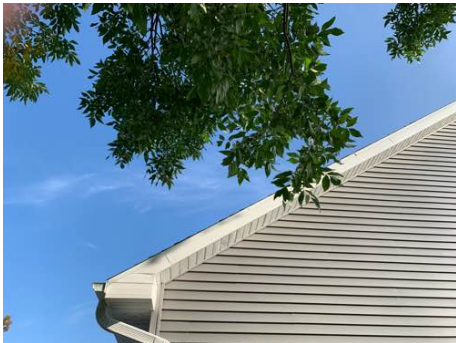
VEGETATION Fair

Recommend keeping trees trimmed. Currently all vegetation is within a good distance from the home.

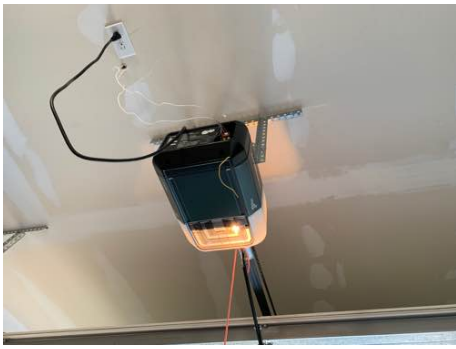
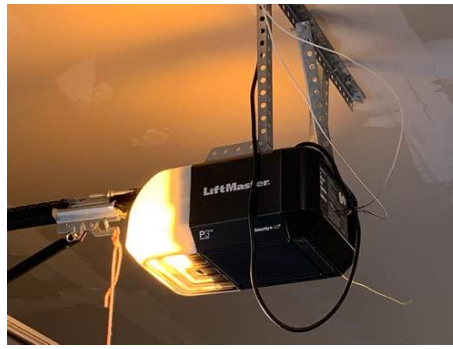
GARAGE DOOR OPENER Satisfactory

Both of the garage door opener's appear to be in like new condition and were able to open.

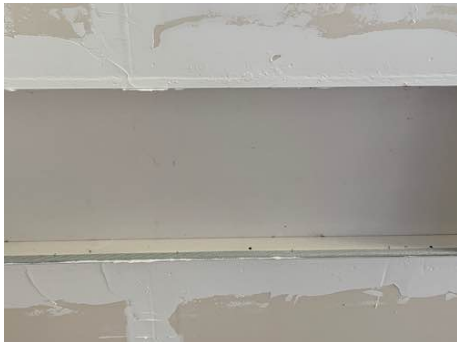
ACCESS Poor

The attic access was nailed shut. Unable to access without damaging the home. Recommend requesting access from seller for further evaluation in the future.

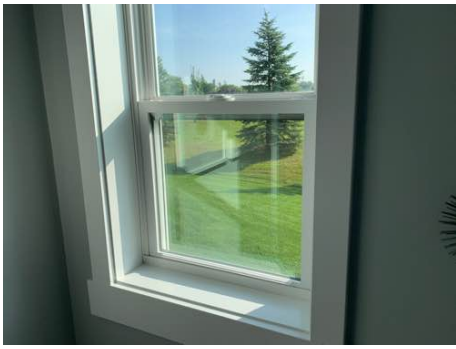
WINDOWS Satisfactory

Vinyl window in like new condition. No signs of moisture or air leaks

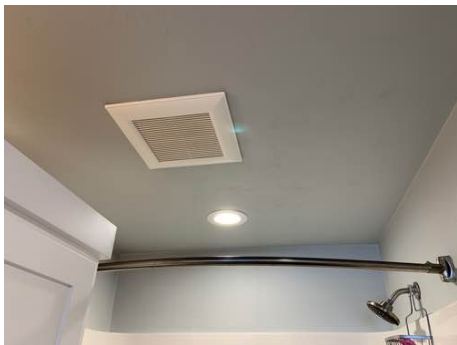
VENTING Satisfactory

The vent above the shower and in the separate toilet room were both operational at the time of the inspection.

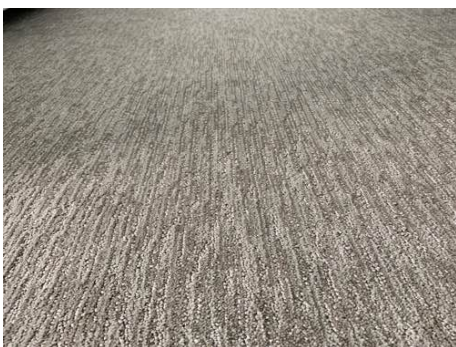
FLOORING Satisfactory

All bedrooms have carpeting which appears to be in like new condition.

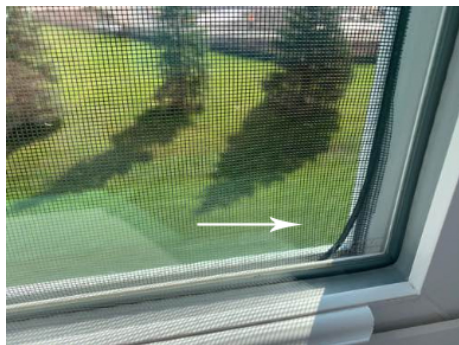
WINDOWS Poor

One screen is damaged in the master bedroom window. Recommend repair / replacement by a homeowner or handyman.

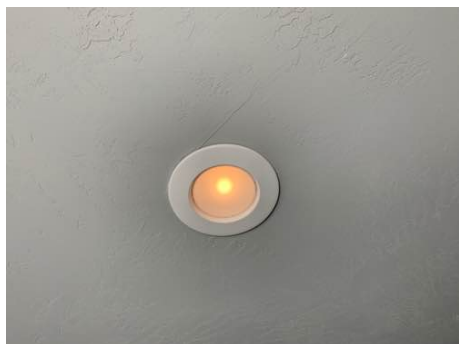
LIGHTING Satisfactory

Operational dimmable LED lighting in master bedroom.

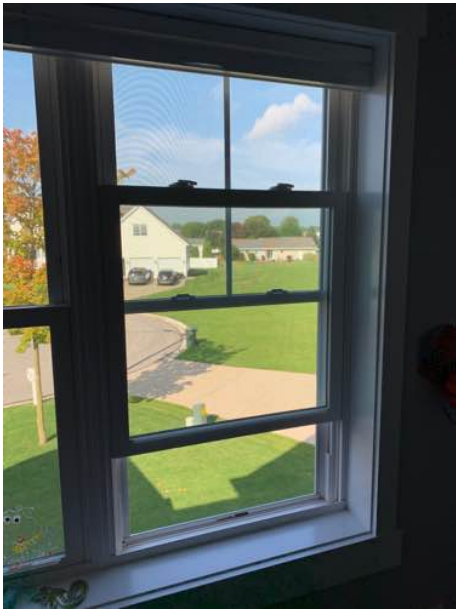
WINDOWS Satisfactory

The vinyl windows open smoothly and are in a like new condition.

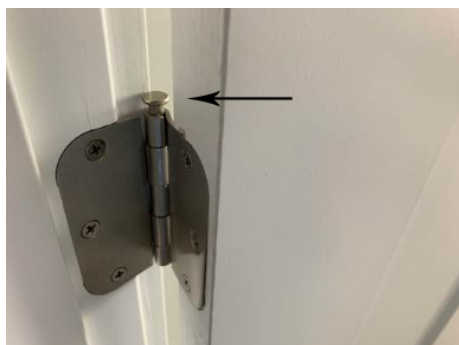
DOORS Fair

There is a squeaky hinge on the north side bedroom door. Recommend greasing the hinge.

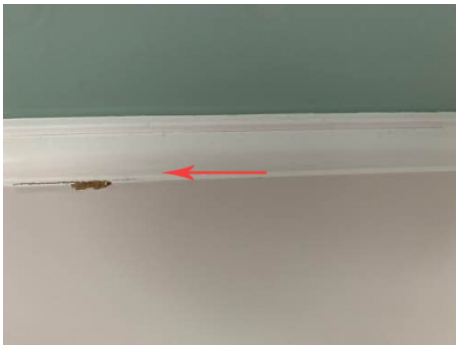
DOORS Fair
Notes:

The doors to the den open and close smoothly. I did notice some chipped paint on one of the doors near the bottom.

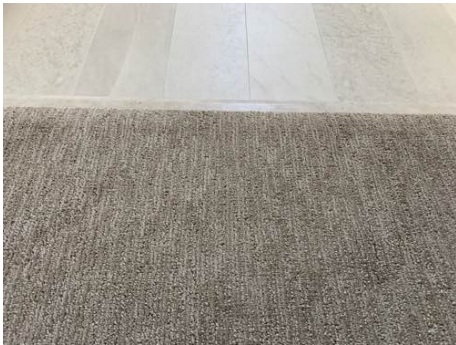
FLOORING Satisfactory

The den is carpeted and in like new condition.

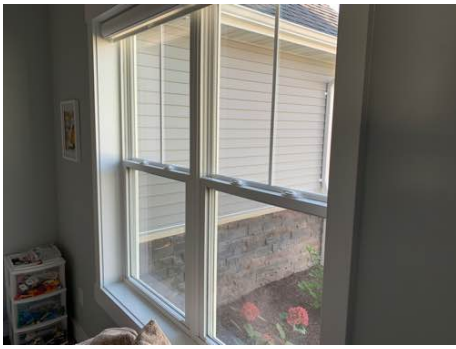
WINDOWS Satisfactory

Vinyl windows throughout all living areas in like new condition.

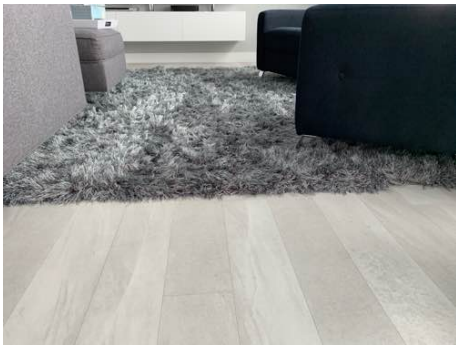
FLOORING Not Inspected

The entire living area is an engineered vinyl tile floor. There is also a large rug covering a majority of the flooring so I was unable to inspect the entire floor. What I could see appeared to be in good condition.

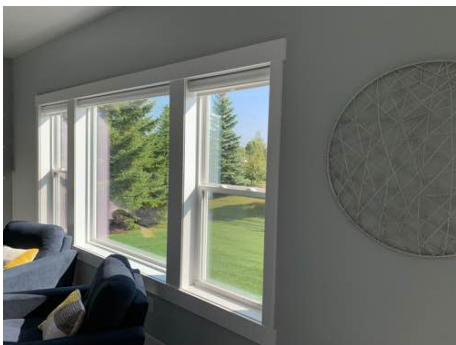
WINDOWS Satisfactory

No signs of air leaks or moisture present.

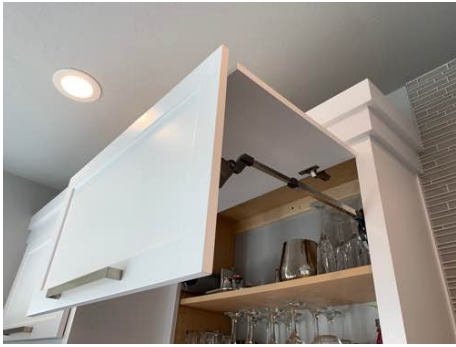
CABINETS Satisfactory

Upper kitchen cabinets open by lifting upward and were operational at the time of the inspection.

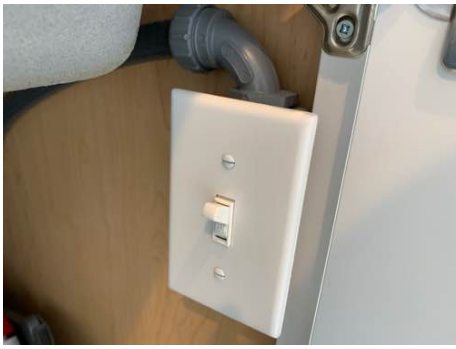
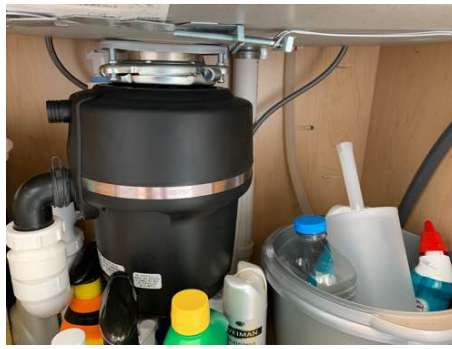
SINK / GARBAGE DISPOSAL Satisfactory

The garbage disposal is operational at the time of the inspection

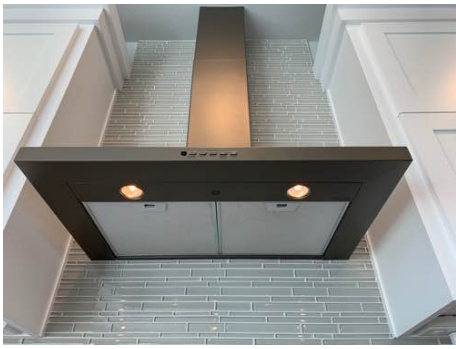
EXHAUST HOOD Satisfactory

The kitchen exhaust hood was operational at the time of the inspection.

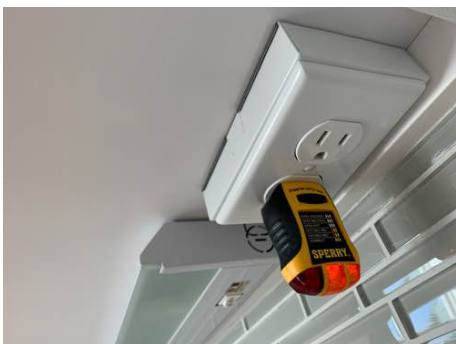
OUTLETS Satisfactory

Located on the bottom of upper cabinets.

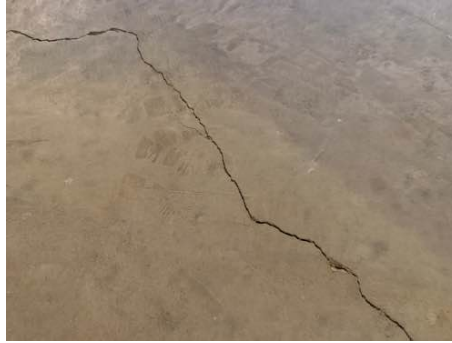
SLAB Satisfactory

Two normal shrinkage cracks were noticed. This is not a major concern however I do recommend you monitor this in the future for any possible movement. Both cracks are located within 3 feet of the bottom of the stairs to the basement.

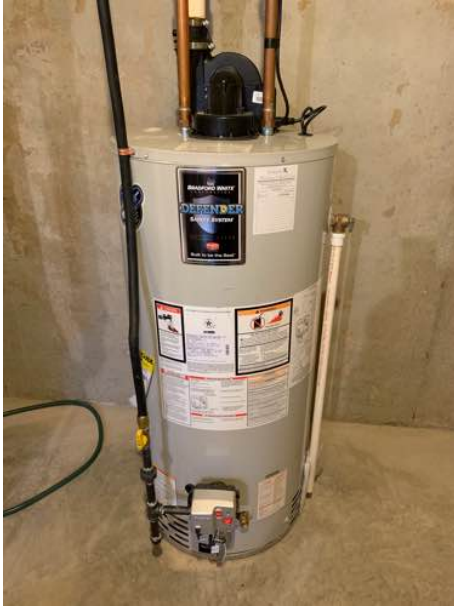
WATER HEATER Satisfactory

The water heater was installed in 2017.

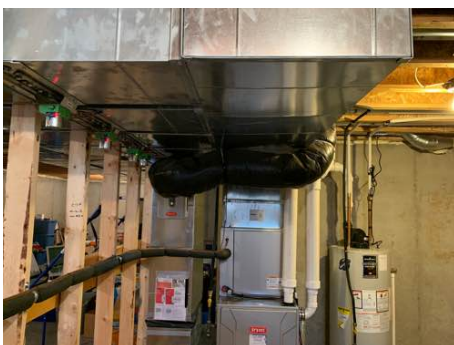
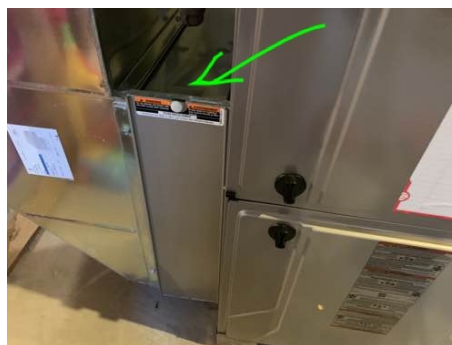
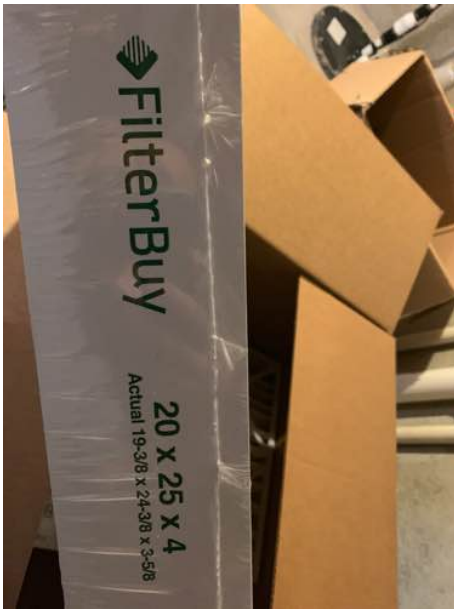
HEATING SYSTEM OPERATION Satisfactory

The forced air unit operated just fine at the time of the inspection and is only two years old. Recommend changing air filters regularly and annual servicing by a qualified hvac technician.

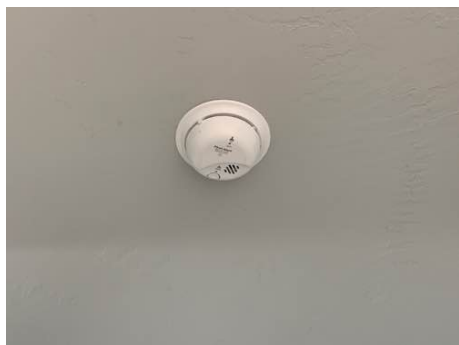
SMOKE ALARM(S) Satisfactory

Recommend checking the batteries in smoke alarms once every month.

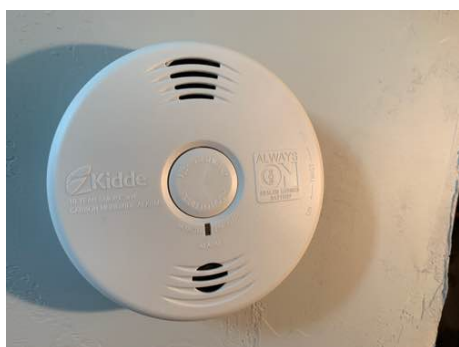
CARBON MONOXIDE ALARM(S) Satisfactory

There is one carbon monoxide alarm installed at the bottom of the stairs to the basement. It is recommended you test it weekly.

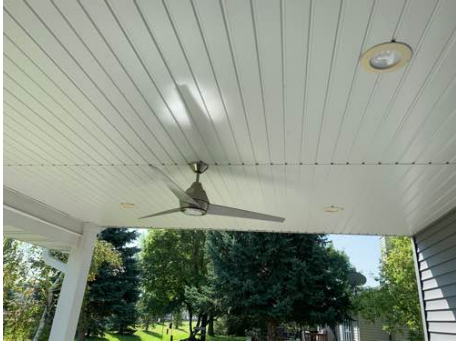
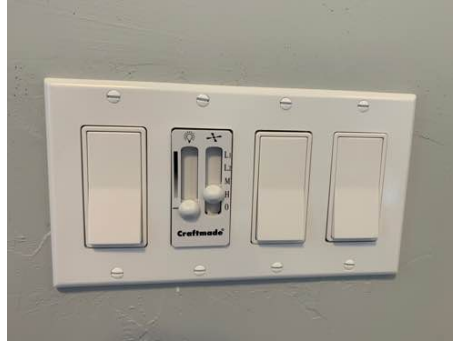
OUTDOOR CEILING FAN ON THE BACK PORCH. Satisfactory

The fan was operational at the time of the inspection.
